Debris/Ice/TPS Assessment and Integrated Photographic Analysis of Shuttle Mission STS-91

**DEBRIS/ICE/TPS ASSESSMENT
AND
INTEGRATED PHOTOGRAPHIC ANALYSIS
OF
SHUTTLE MISSION STS-91**

2 June 1998

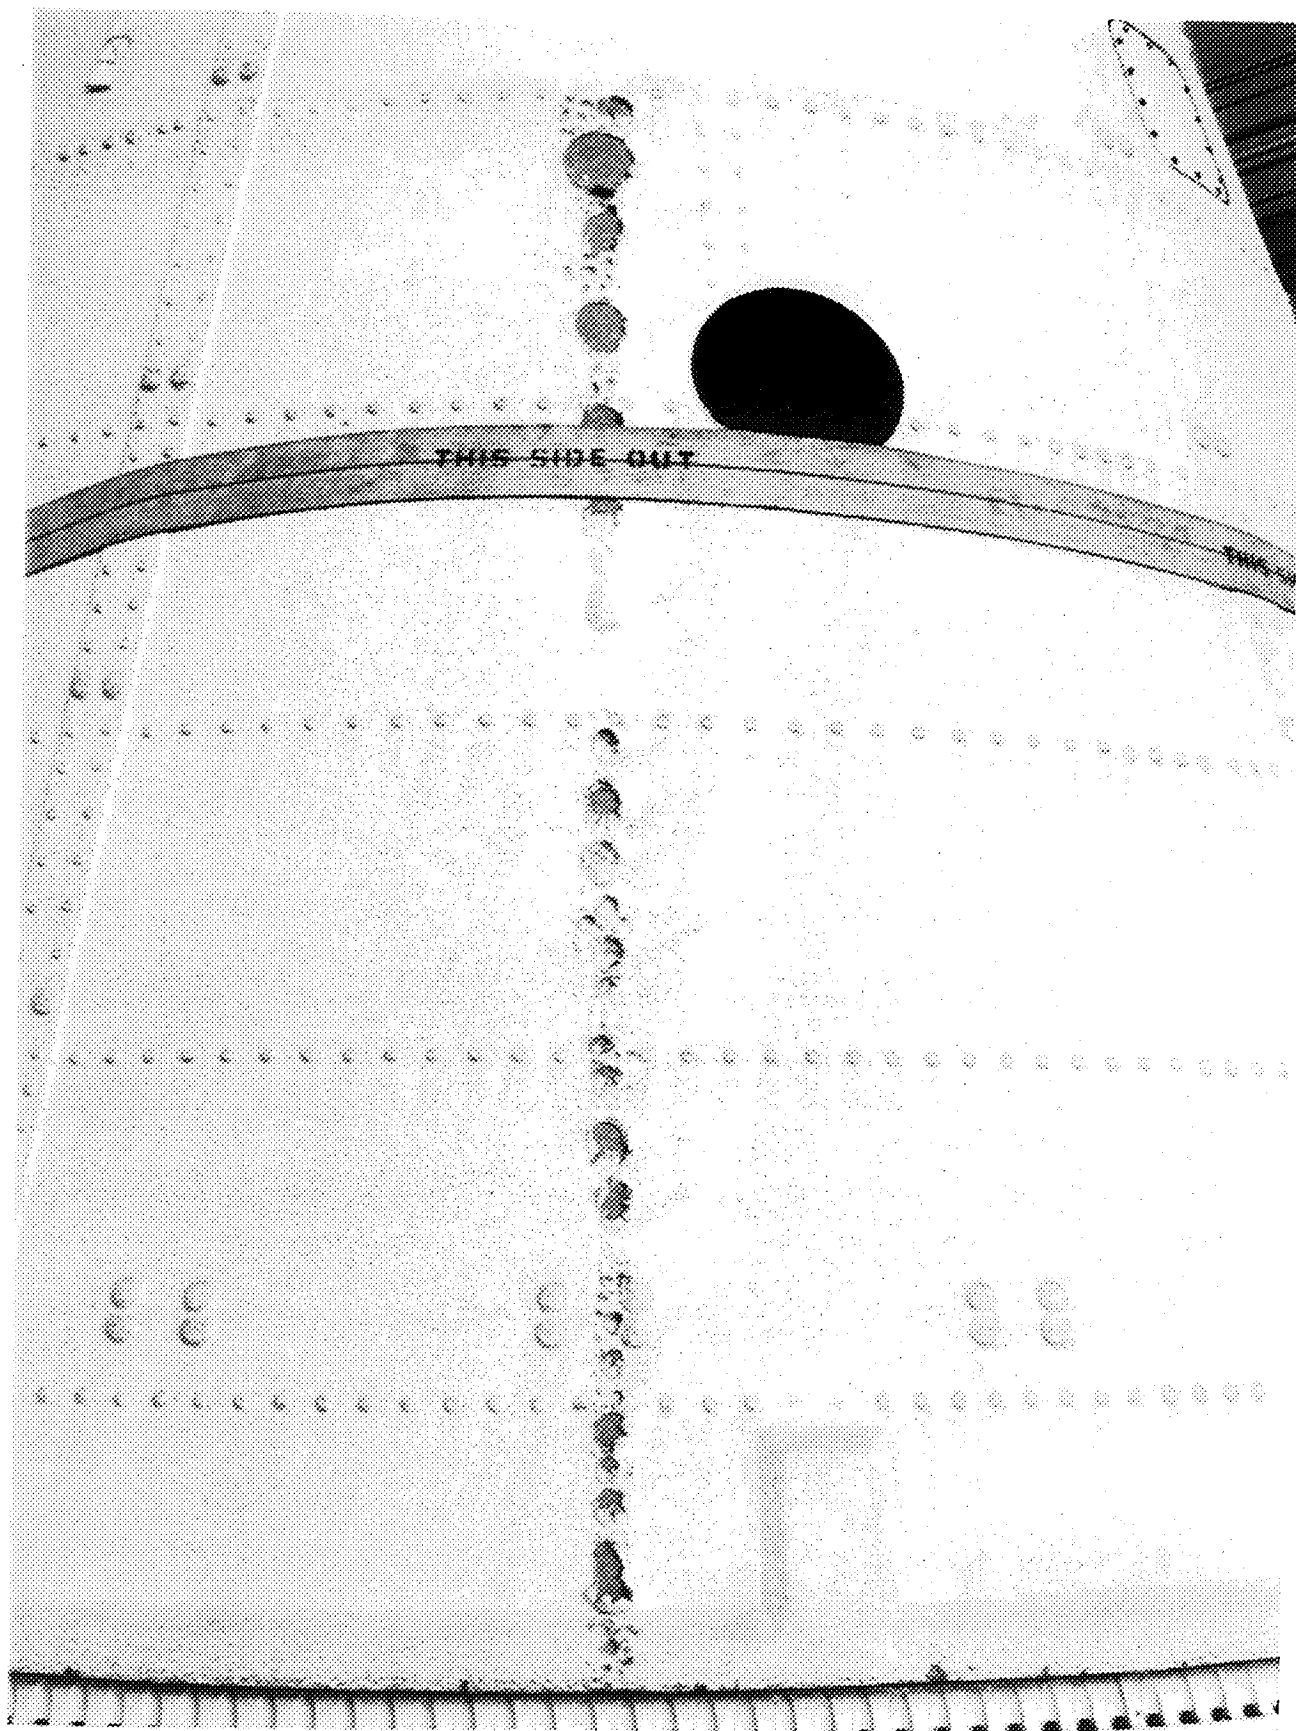
Photo 38: Blistered Hypalon Paint

Virtually none of the Hypalon paint had blistered or peeled with the exception of a fore-to-aft line of BTA closeout on the -Z side of the right frustum.

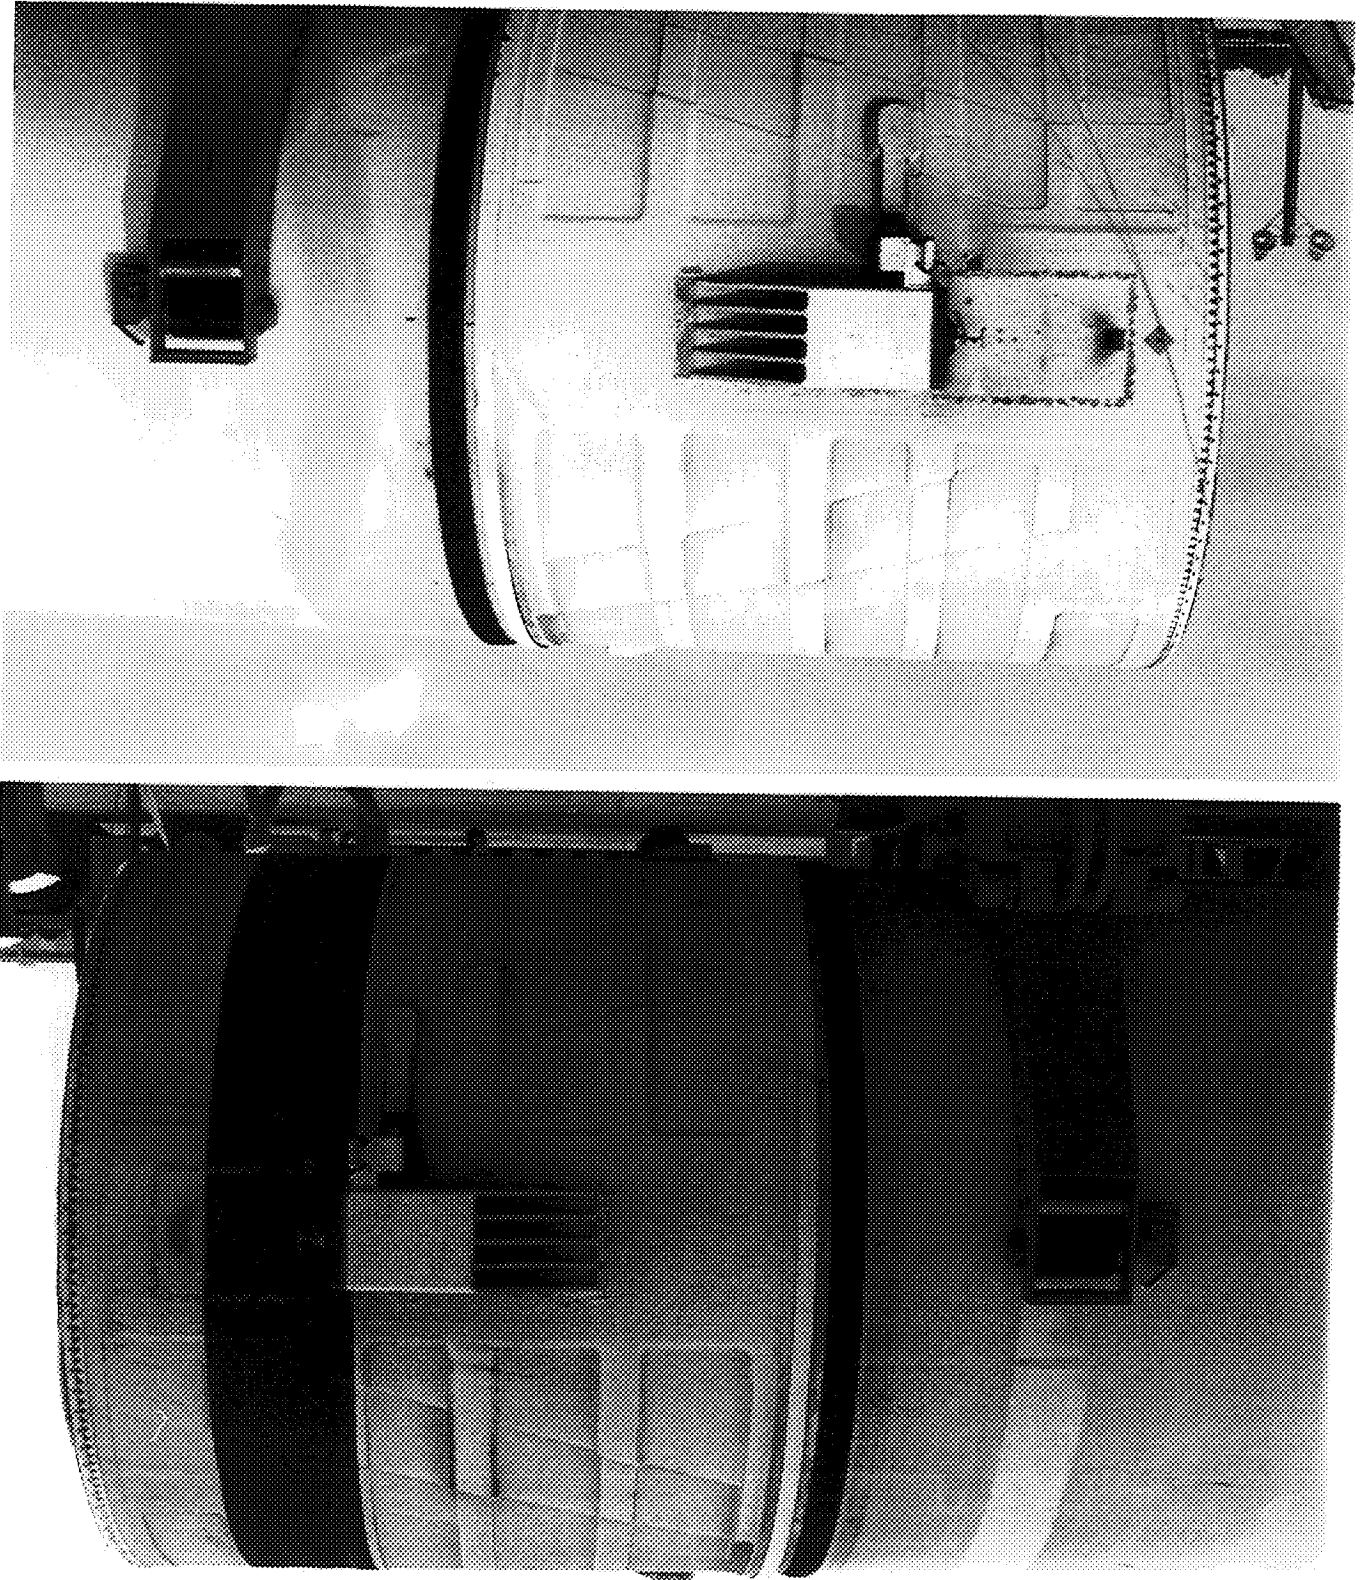
Photo 39: Forward Skirt Post Flight Condition

The forward skirts exhibited no debonds or missing TPS. RSS antennae covers/phenolic base plates were intact though one phenolic layer on both +Z and -Z sides of the right SRB antenna base plates had delaminated. Hypalon paint was blistered/missing over the areas where BTA closeouts had been applied. All truss/severance ring pins and retainer clips were intact.

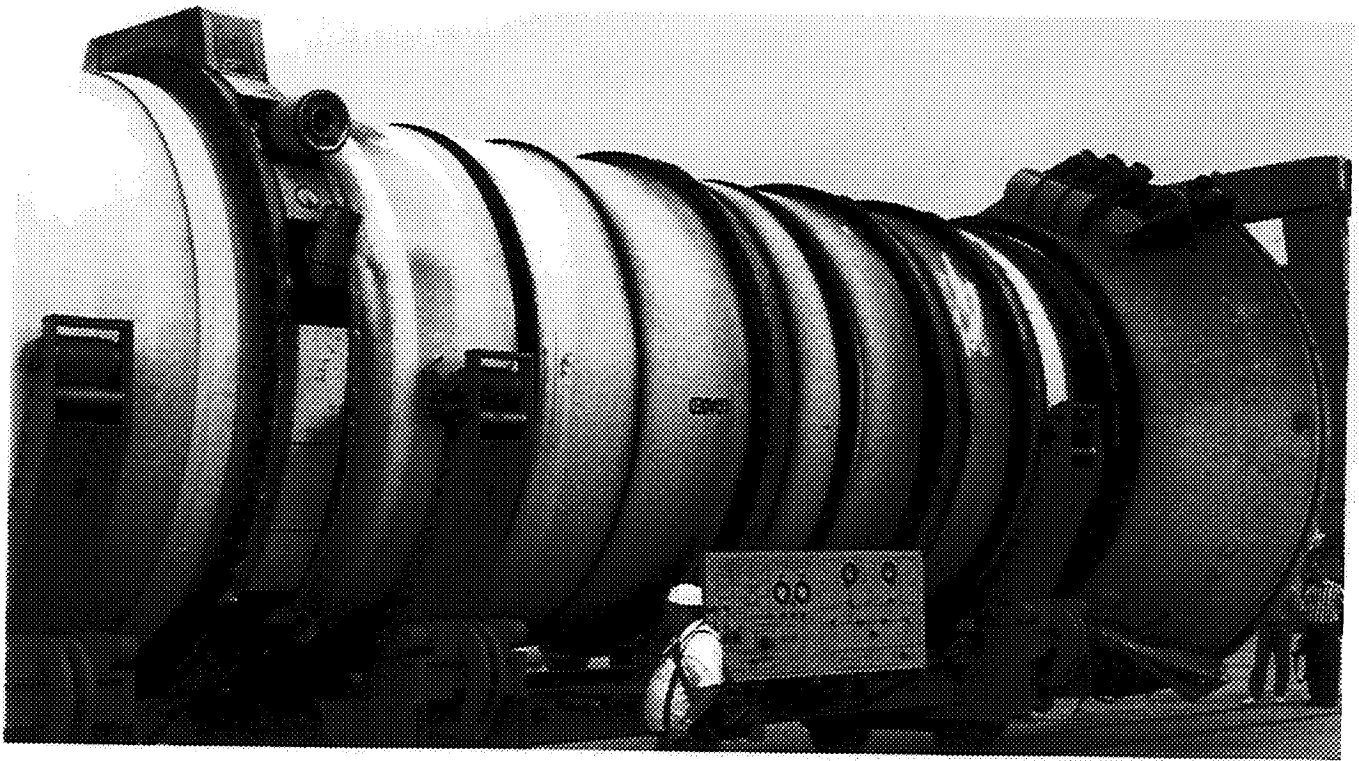
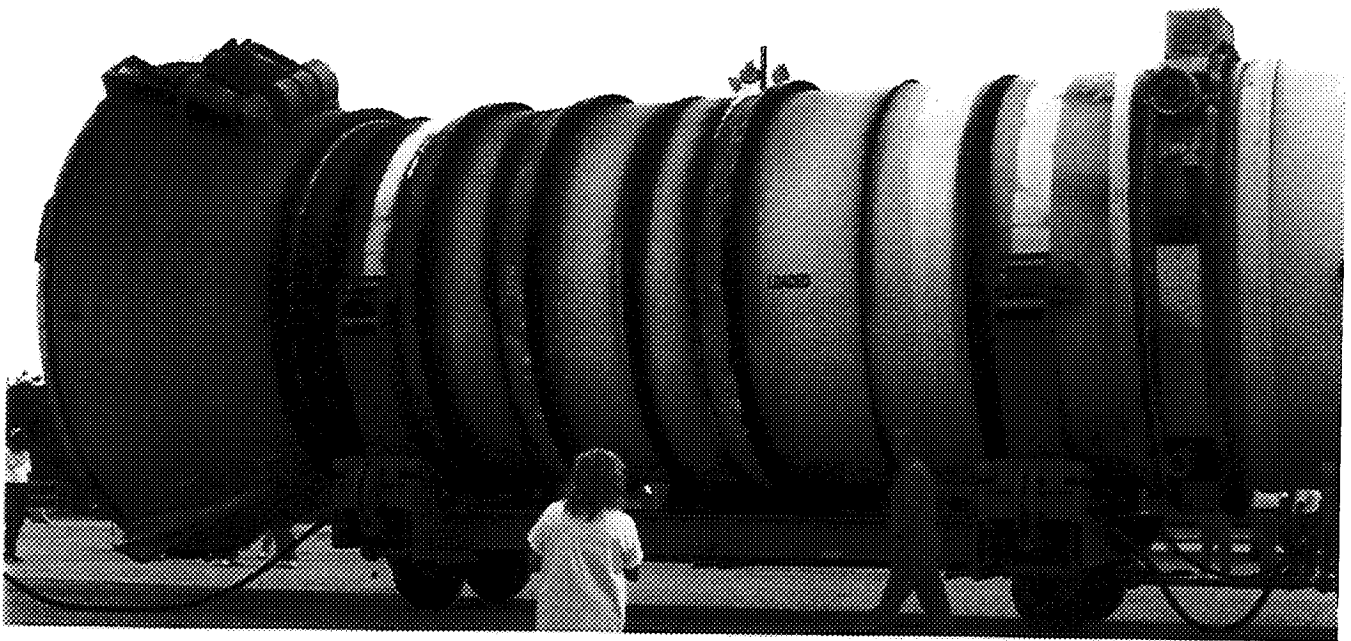
Photo 40: Aft Booster/Aft Skirt Post Flight Condition

Separation of the aft ET/SRB struts appeared normal. TPS on the external surface of both aft skirts was intact and in good condition.

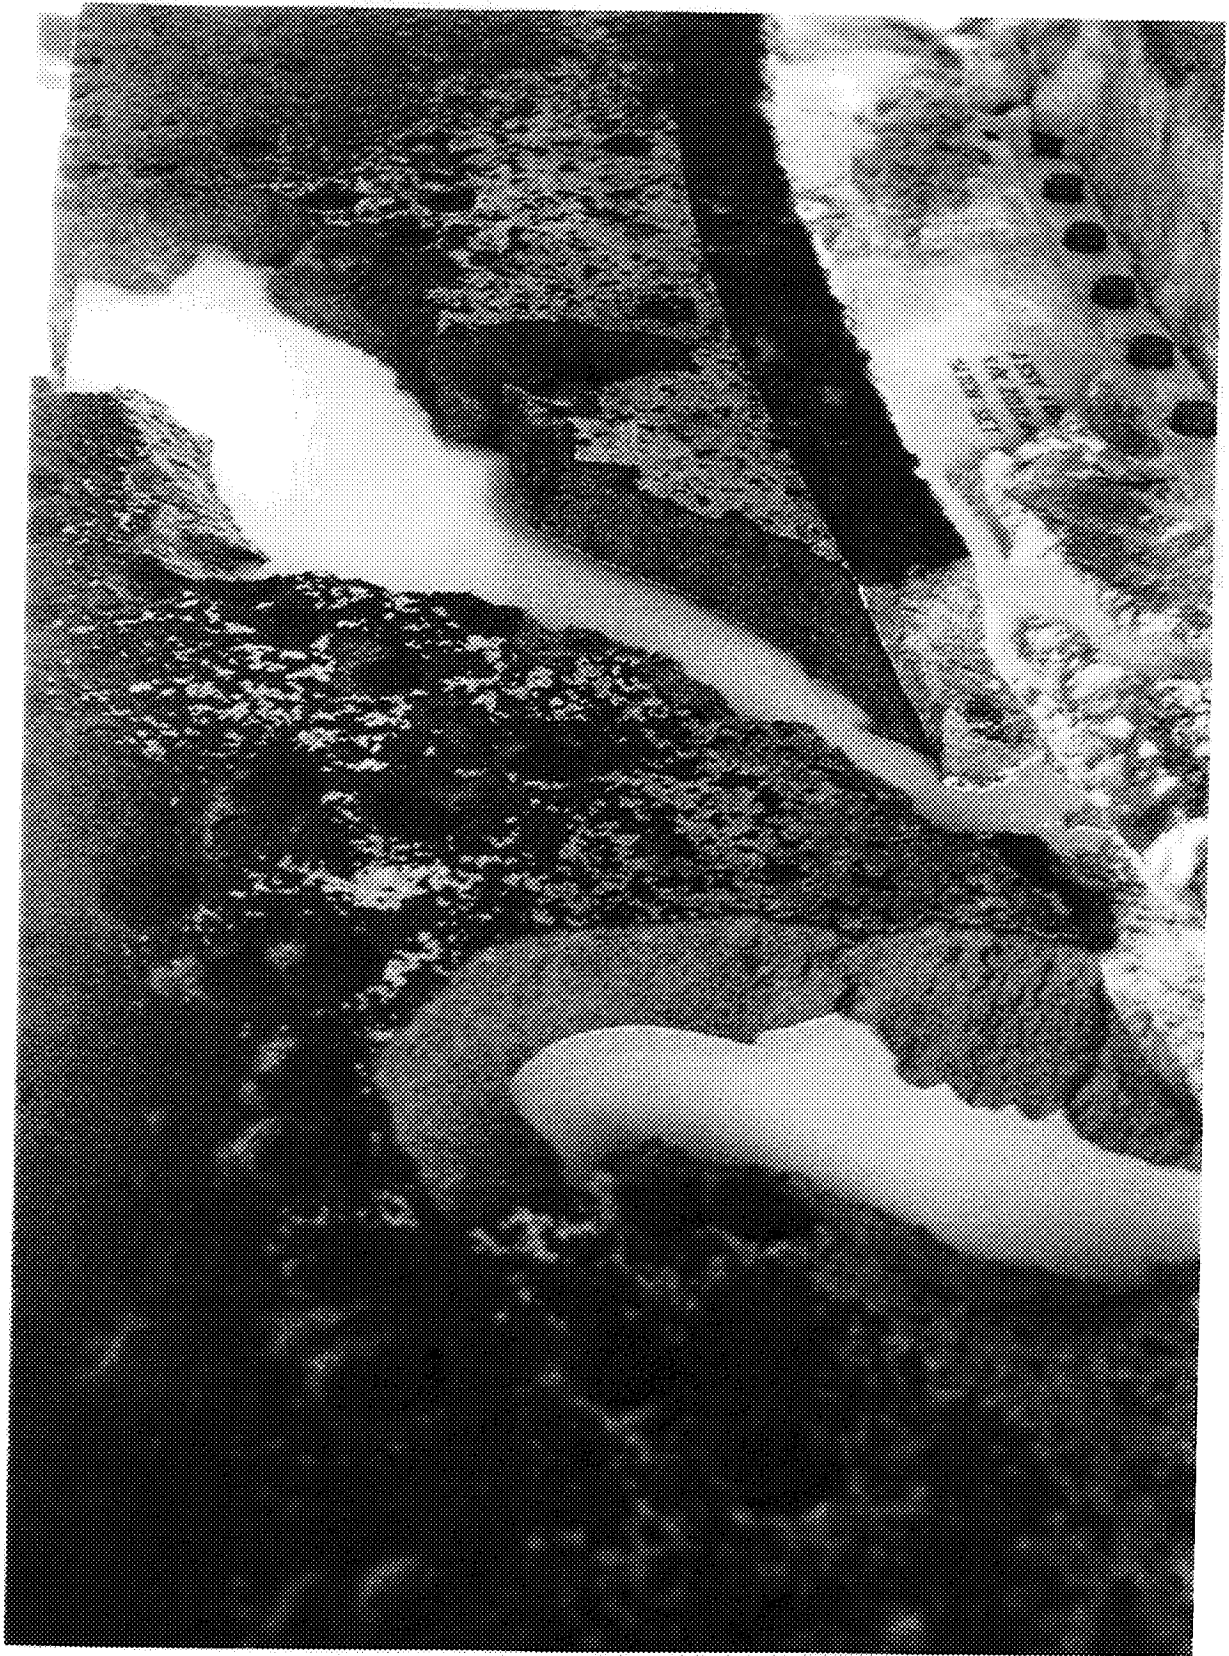
Photo 41: Missing IEA Insulation/Cork

Significant areas of missing insulation/cork from the aft surface of the IEA showed the insulation had not bonded properly. The pristine condition of the primed substrate indicated the insulation was lost at water impact rather than in flight.

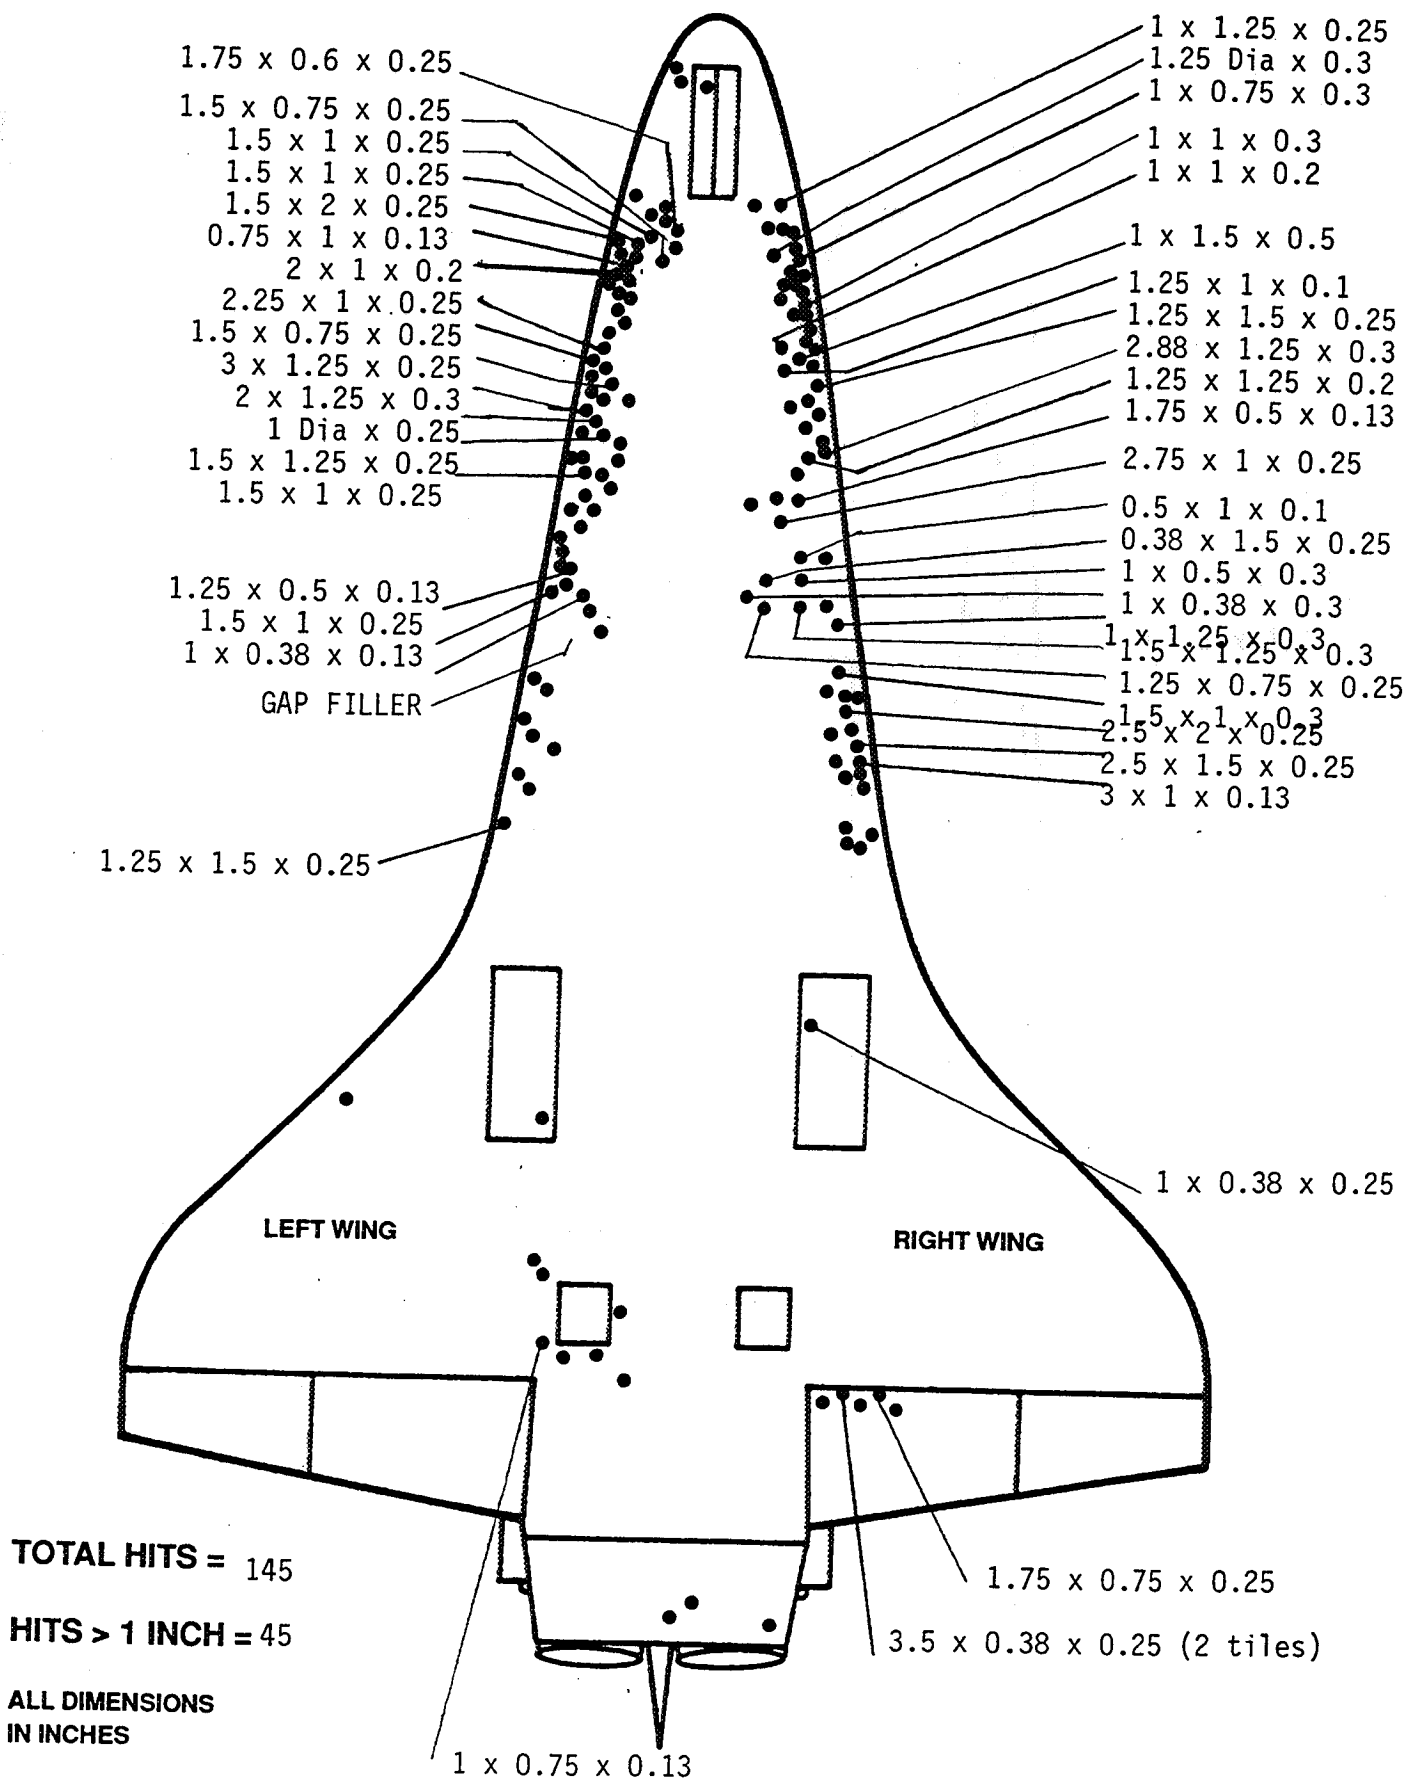
Figure 1: Orbiter Lower Surface Debris Damage Map

The Orbiter lower surface sustained 145 total hits, of which 45 had a major dimension of 1-inch or larger. Most of this damage was concentrated aft of the nose to the main landing gear wheel wells on both left and right chines. Virtually no damage occurred on the Orbiter centerline. These damage sites follow the same location/damage pattern documented on STS-86, STS-87, STS-89, and STS-90, though it should also be noted that this was the first flight of the new Super Light Weight Tank. The average size and quantity of damage sites were greater than the favorable trend established on STS-89 and STS-90:

The largest lower surface tile damage site forward of the main landing gear wheel wells was located on the left chine and measured 3-inches long by 1.25-inches wide by 0.25-inches deep. The deepest lower surface tile damage site of 0.5-inches was located on the right chine.

The Space Shuttle Program continues to work an IFA to prevent loss of foam from the ET thrust panels and preclude further damage to Orbiter tiles.

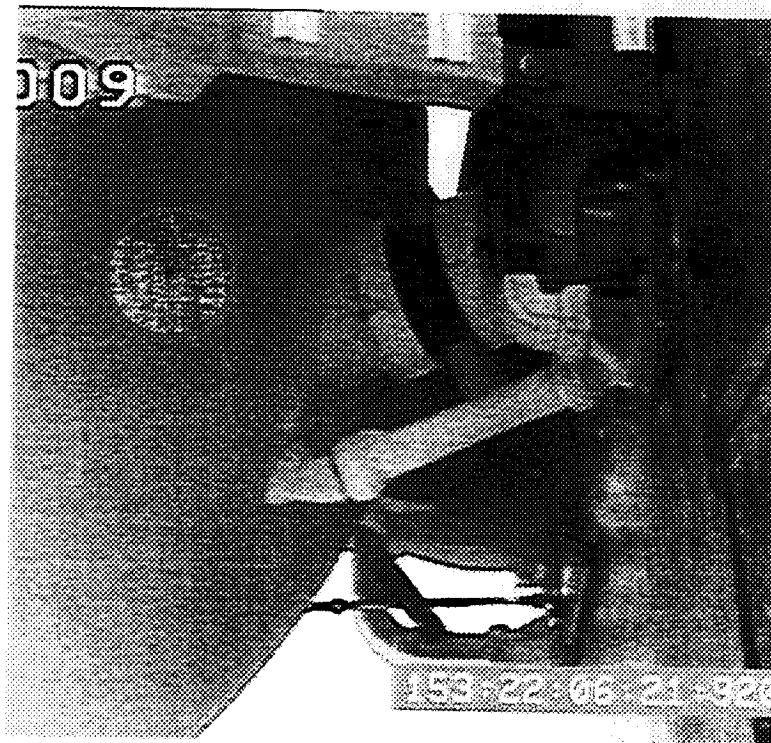
Figure 2.1 (A) Dark-Colored Debris at SSME Ignition

A small dark-colored piece of debris (possibly an insect) was seen near the left ET/Orbiter attach aft strut during SSME ignition (22:06:21.920 UTC) on camera OTV009.

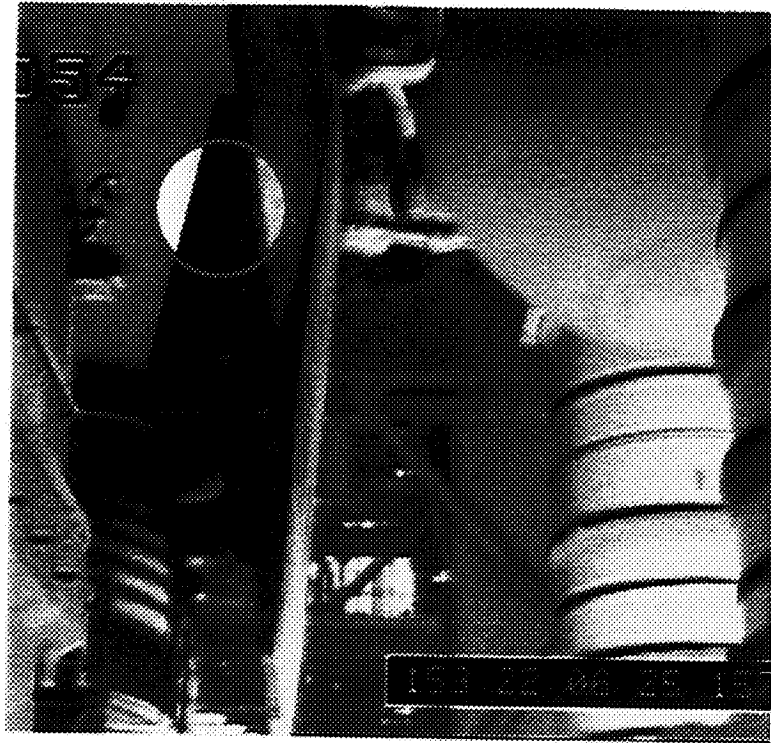
Figure 2.2 (A) Debris Near Right Wing During Liftoff

A single light-colored piece of debris was seen near the upper surface of the right wing during liftoff (22:06:25.157 UTC) on camera OTV054. This debris was probably not from the starboard water relief nozzle according to engineers investigating the water leak anomaly.

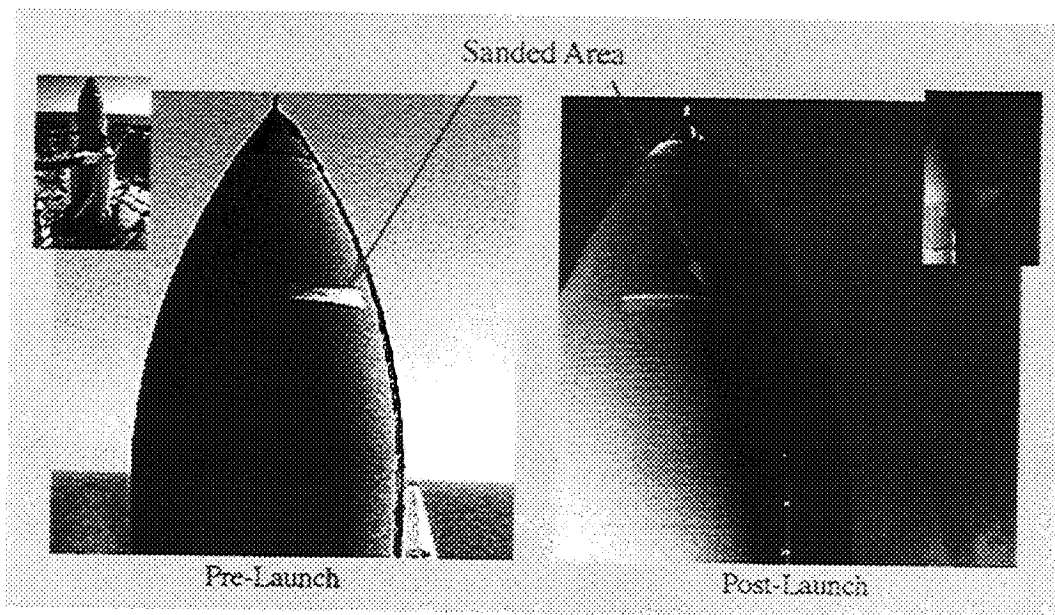
Figure 2.5.1 (A) Sanded Area on ET Nose Cone

The LH2 tank and the LO2 tank/Ojive TPS appeared to be in excellent condition on the close-up 35mm umbilical well camera film. The sanded area on the ET nose cone appeared undamaged. Similar to STS-90 and other previous missions, a gray-colored band of pock marked or possible missing TPS is visible on the +Z ET nose just aft of the ET nose cone fairing. Discoloration in this area is probably due to aero friction and heating.

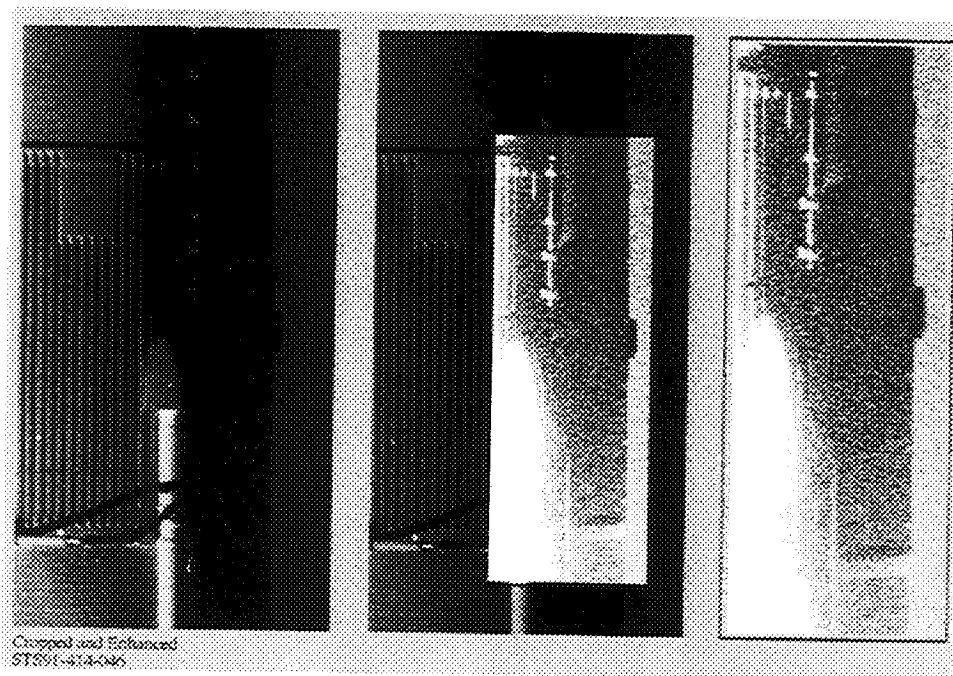
Figure 2.5.1 (B) ET +Y Thrust Panel

The visible portion (+Z/+Y) of the right SRB thrust panel was in shadow on the 35mm umbilical well film. Digital enhancements were made from the film in an attempt to detect TPS damage on the right ET intertank thrust panel. However, the presence of damage on this panel could not be confirmed. The left SRB thrust panel was not imaged on the 35mm umbilical well film.

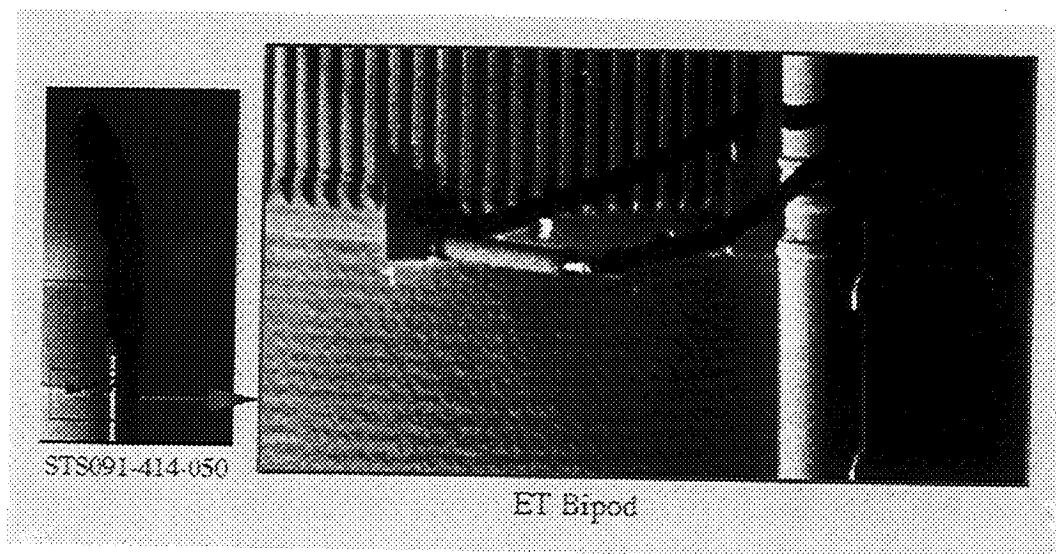
Figure 2.5.1 (C) Divot on ET Close-out Flange

A divot, approximately seven inches in size, was visible under the ET/Orbiter attach bipod in the LH2 tank-to-intertank close-out flange. The divot was not deep enough to show primed substrate. A shallow light-colored mark (possible divot) approximately three-inches in size was visible just aft of the left leg of the bipod in the LH2 tank TPS. The bipod jack pad close-outs appeared intact.

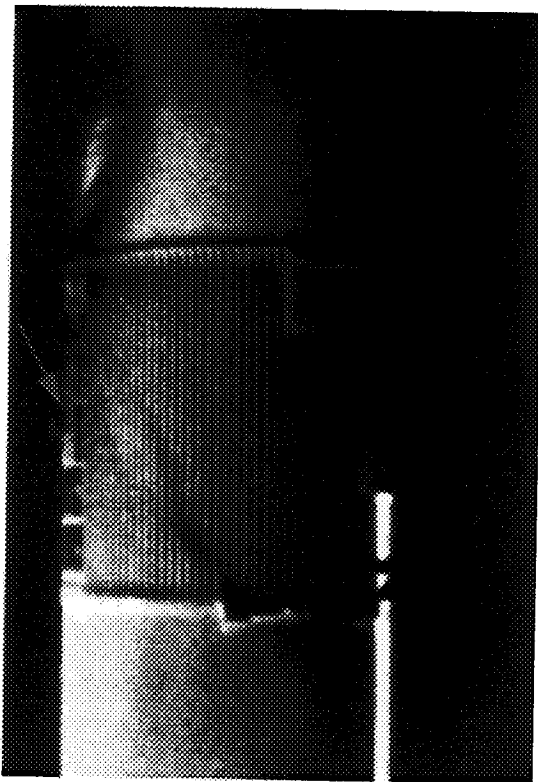
Figure 2.5.1 (D) ET -Y Intertank Thrust Panel (16mm Umbilical Film)

A large bright-colored area of possible divots was noted on the forward portion of the visible (-Y/+Z) left intertank thrust panel. Other light-colored marks were seen on the left intertank thrust panel. However, some of these light-colored marks appeared to coincide with small ramps on the thrust panel seen on the close-out photography and may not indicate damage.

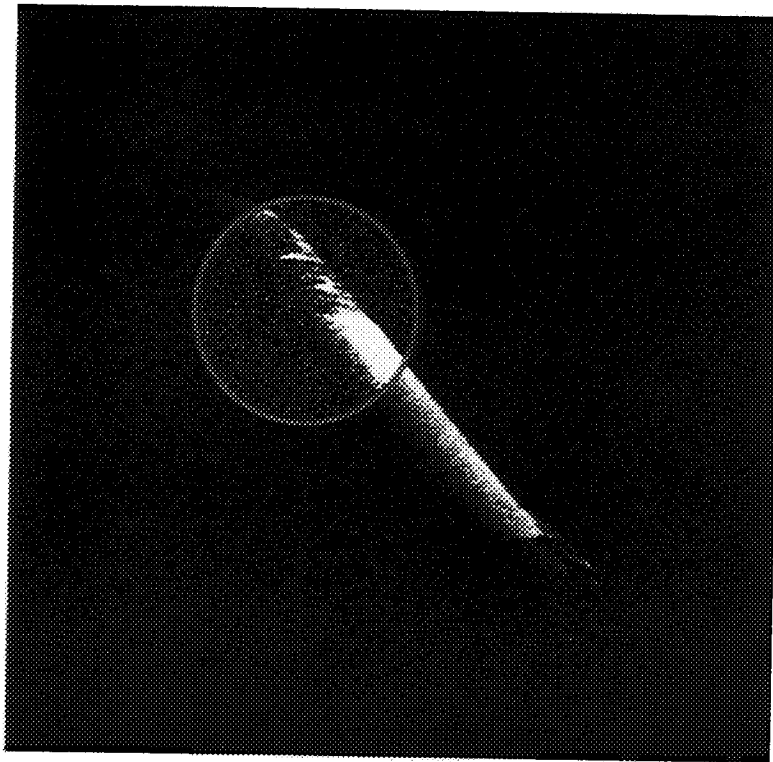
Figure 2.5.2.1 (A) ET -Y Intertank Thrust Panel (Handheld Film)

Damage to the external tank, including both intertank thrust panels, was not confirmed from the available handheld camera views. However, approximately five light-colored marks were visible on the -Y thrust panel forward of the EB fitting. An additional three to four light-colored marks were noted on the close-out flange between the forward end of left intertank thrust panel and the LO2 tank TPS. These light-colored marks may indicate possible damage, but this was not confirmed because of the limited resolution.

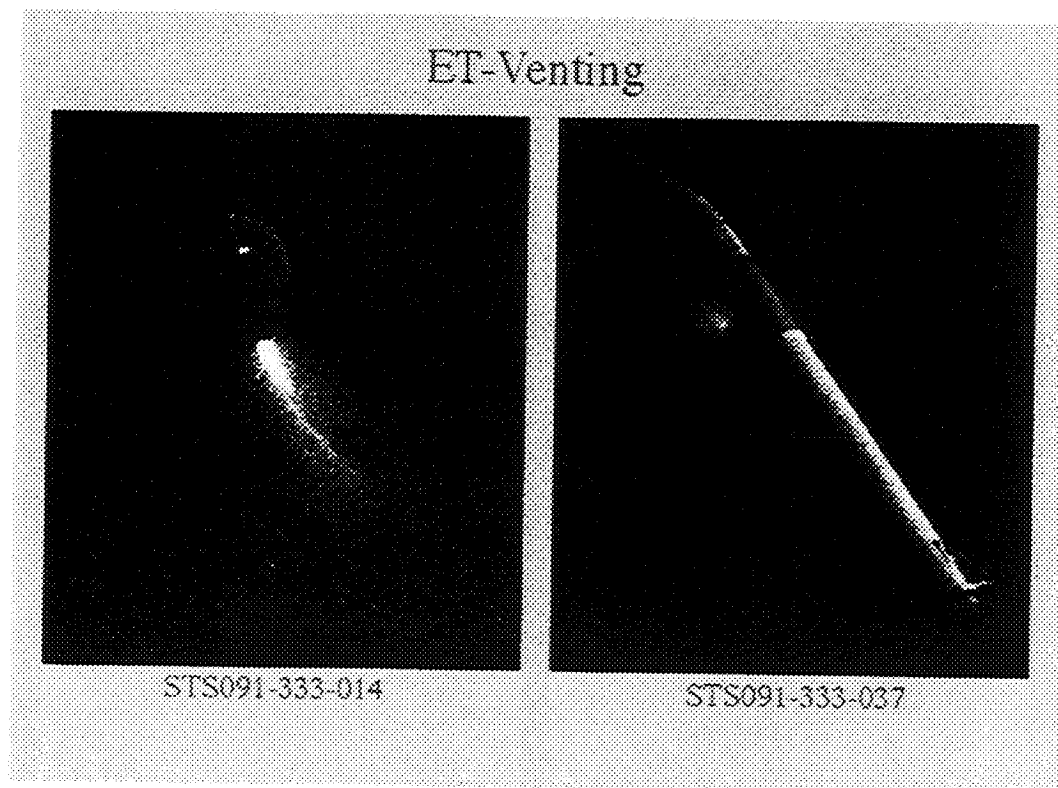
Figure 2.5.2.1 (B) ET Venting

Venting from what appeared to be the -Y intertank hydrogen vent was recorded on ten frames (see Table 2.5.2.1).

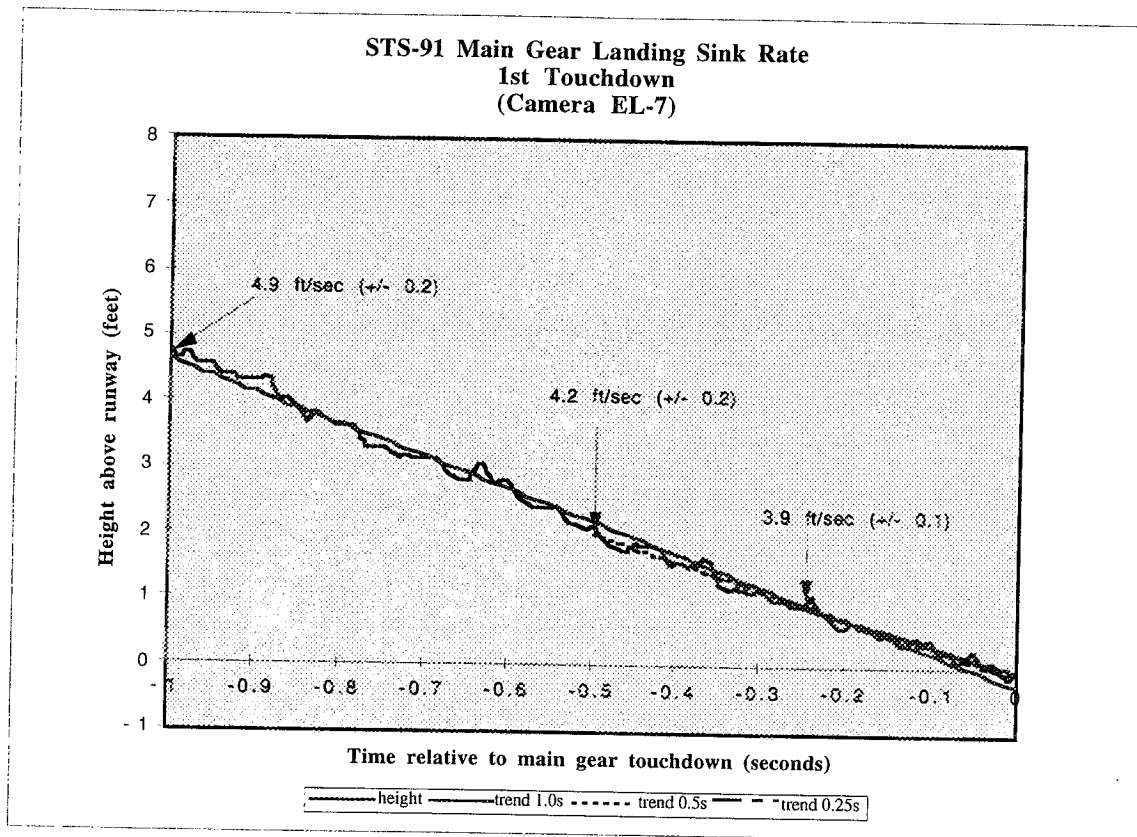
Figure 2.6.1 (A) Landing Sink Rate (1st Touchdown)

The left main gear sink rate for STS-91 landing at one second, at half a second, and at a one quarter of a second are provided in Tables 2.6.1 (A) and 2.6.1 (B). Plots of these sink rates are provided in Figures 2.6.1 (A) and 2.6.1 (B).

The maximum allowable main gear sink rate values are 9.6 ft/sec for a 212,000 lb. vehicle and 6.0 ft/sec for a 240,000 lb. vehicle. The landing weight of the STS-91 vehicle was estimated to be 226,725 lbs.
